PROJECT OF THE YEAR

Metropolitan Council Environmental Services (MCES) Minnehaha Park Area Sewer Rehabilitation

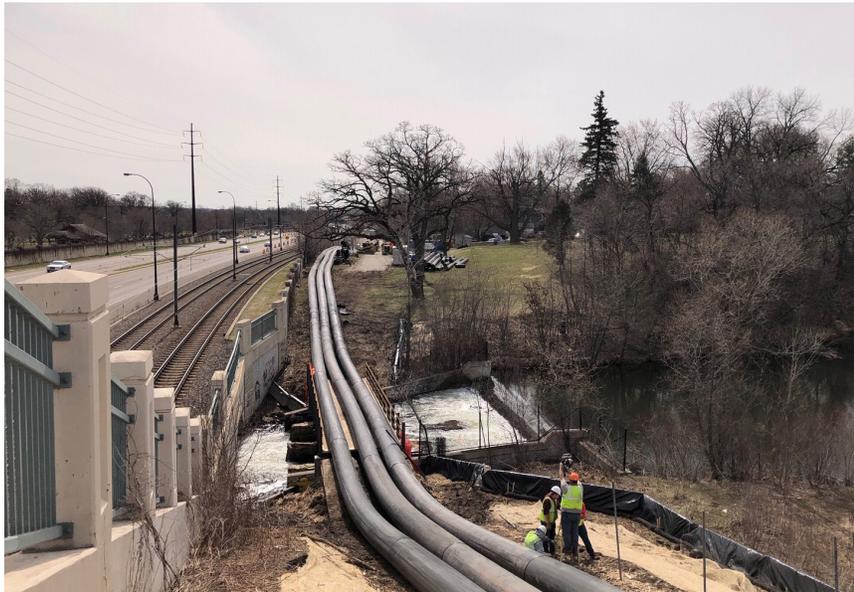
Figure 1. Temporary conveyance of wastewater over Minnehaha Creek

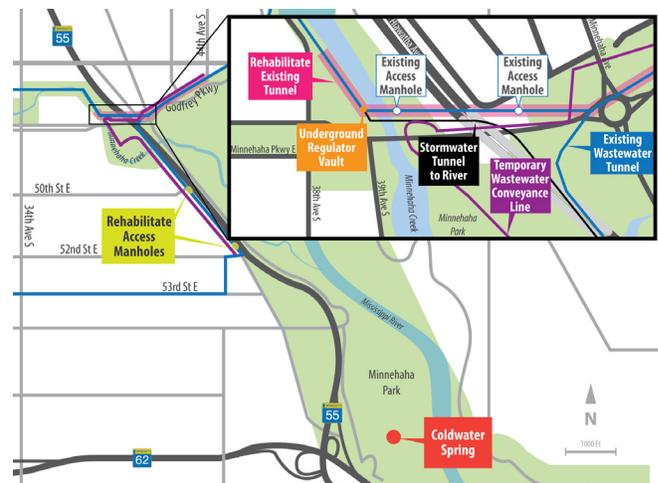
Figure 2. Project map

interceptors. ERS-04, located adjacent the Minnehaha Park in Minneapolis as shown in Figure 2, was designed to protect upstream residential areas as well as the downstream interceptor system. Due to deliberated and intense sewer separation and infiltration/inflow reduction programs, there has not been a release of wastewater at ERS-04 for over 17 years. However, because of the age of these facilities and due to their corrosive environments, rehabilitation of the relief structure, deep tunnel sections and vortex drop shafts became necessary to provide safe, reliable service over the next 80 years.

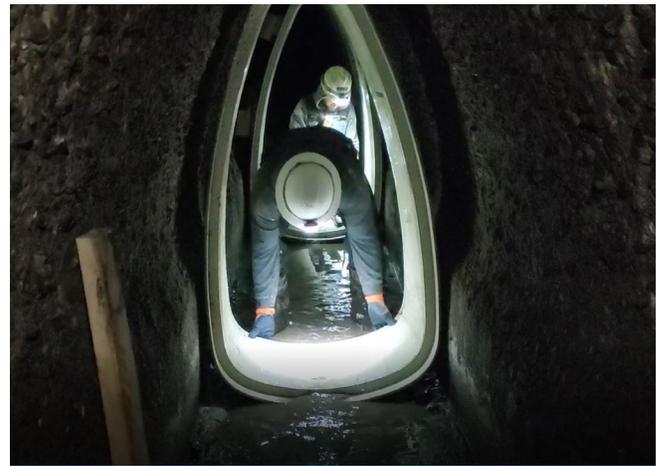
Figure 3. Liner installation

Rehabilitating an 80-year-old non-circular sewer located 75 feet below the ground surface presented many unique challenges, which were solved through careful planning and innovative solutions from the design team and the contractor. The unique shape of the 6-ft tall, inverted horseshoe sewer required the application of custom liners, which were provided by Channeline® and manufactured in Dubai, UAE. Installation of these custom fabricated structural shapes required temporary conveyance of the wastewater around the deep tunnel sections, field measurement of the sewer profile, custom fabrication and trans-oceanic shipment of the sections. All requiring careful planning and scheduling by the contractor. Arriving onsite, the over 700 two-ft liner sections were numbered and staged for insertion into the 60-ft deep access shafts. Figure 3 shows the liner sections being placed in the tunnel.

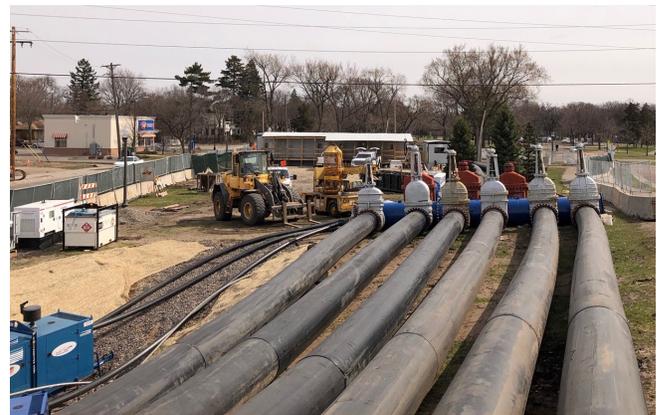
Figure 4. Discharge manifold and piping

The temporary conveyance systems were carefully designed to maintain safe and reliable conveyance of wastewater around the construction site and monitored to provide continuous operation. With capacities of over 59,000 gpm, multiple systems were deployed with the necessary redundancy and back-up power systems. The discharge manifold and piping for the largest of the temporary conveyance systems is shown in Figure 4.

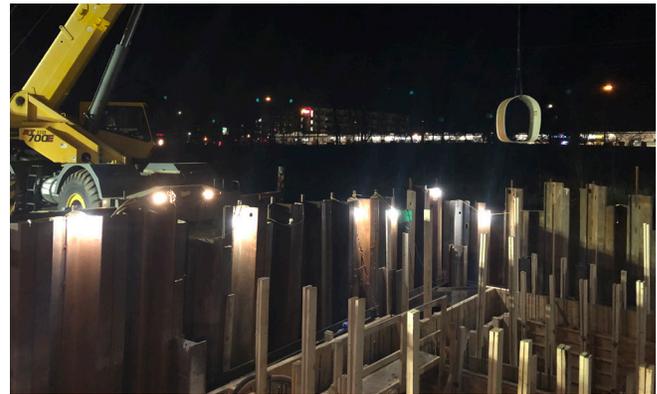
Figure 5. Night-time installation of tunnel sections

Additional measures that were taken to facilitate timely construction included tunnel lining during the night-time to avoid interferences with day-time work on the ERS-04 structure. Figure 5 shows crane operation during night-time insertion of the liner sections.

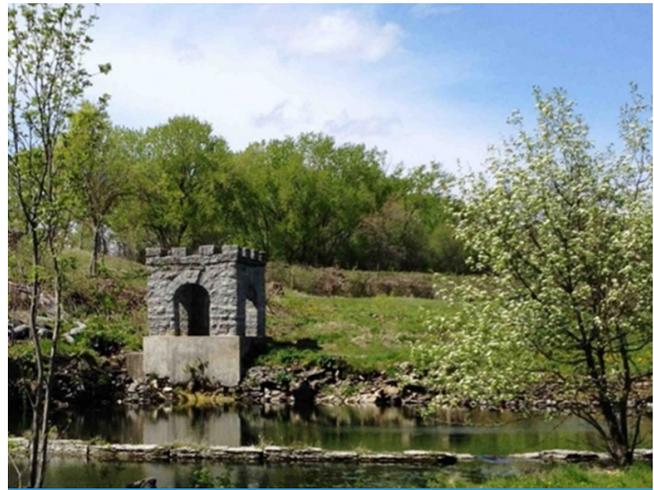
Figure 6. Coldwater Spring – Headhouse and Pond

CWS flows out of the limestone bedrock approximately 1.5 miles southeast of the project site. It was used as a source of drinking water by native Americans for hundreds of years and by soldiers during and after construction of Fort Snelling in the 1820s. Because of its historical and cultural significance, the spring is protected by Minnesota Statute. Because of possible hydraulic connectivity between the spring and limestone fractures in the project area, site dewatering had the potential of altering flows to the spring.

Groundwater investigations were performed in the project area in an attempt to assess the movement of groundwater and to avoid interrupting, plugging or redirecting groundwater. Cores were drilled into the bedrock to locate both horizontal and vertical fractures that could carry water to CWS. Figure 6 shows the historical CWS headhouse where groundwater comes to the surface downstream of Minnehaha falls. Because of the inability to definitively determine the direction and volume of groundwater movement in the area, more conservative construction techniques were implemented to avoid the need for site dewatering within the affected aquifers.

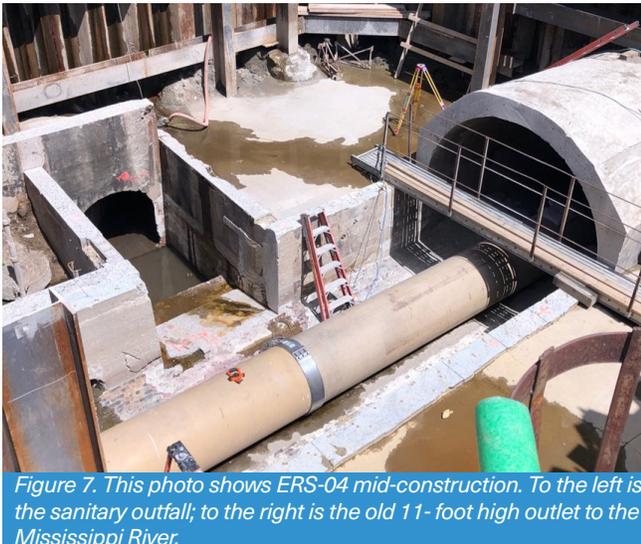
Figure 7. This photo shows ERS-04 mid-construction. To the left is the sanitary outfall; to the right is the old 11-foot high outlet to the Mississippi River.

At the regulator structure, excavation revealed concrete deterioration far greater than had been anticipated. The evidence pointed to improper concrete placement at the time of the original construction requiring additional demolition to expose competent concrete to ensure a sound structure for the future.
