APWA MINNESOTA CHAPTER PUBLIC WORKS PROJECT OF THE YEAR NOMINATION FORM

Project Nominated: City of Chanhassen, Highway 101 Improvements

Project Description

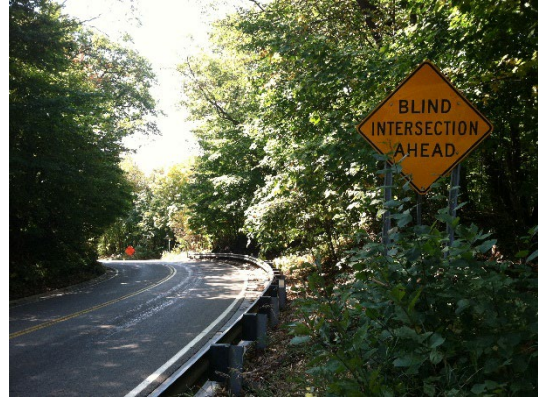
FIGURE 1: EXISTING CONDITIONS SHOWING TIGHT CURVES AND STEEP GRADE

Due to the existing tight curves and steep grades, entirely new horizontal and vertical alignments were established during the design. The project team evaluated four different horizontal alignments—each alignment was evaluated based on adjacent property impacts, access to properties, historical significance, and environmental impacts. The existing roadway consisted of steep grades approaching 15% which created significant safety and maintenance concerns and required some unique approaches to manage stormwater. The preferred design of an 8% roadway grade required cuts of up to 43 feet and the removal of more than 430,000 cubic yards of material.

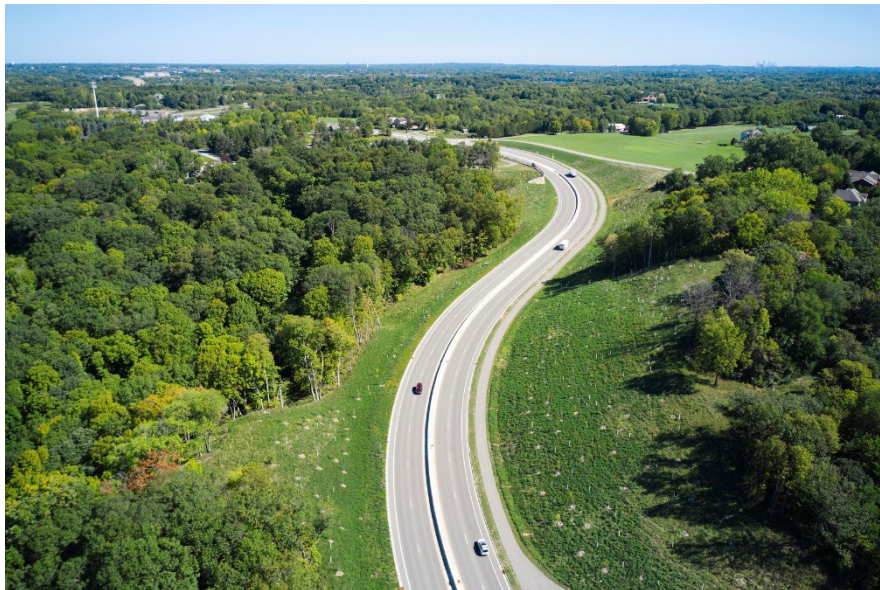
FIGURE 2: NEWLY CONSTRUCTED CSAH 101

The **CSAH 101 Improvements** project included the reconstruction of one mile of two-lane rural section roadway to four-lane divided urban section roadway between Flying Cloud Drive and Pioneer Trail in Chanhassen. The existing project corridor consisted of steep grades and sharp curves which resulted in continuous safety issues. The steep grades were often challenging to traverse during the winter months due to slick conditions and maintenance crews were continually committing resources to the roadway to keep it passable. The reconstruction of this segment was the last link needed to complete the decades-long turnback of TH 101 to Carver County between TH 5 and the Minnesota River bridge crossing to Shakopee. This portion of the roadway was the most challenging segment to implement with an entirely new roadway alignment and deep cuts through the Minnesota River bluff to achieve an acceptable roadway grade.

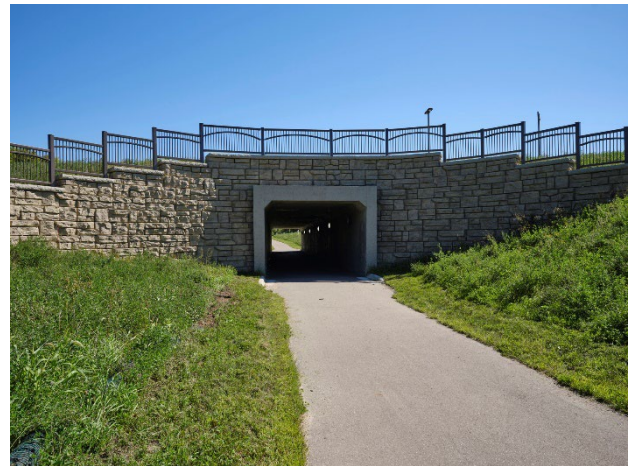
FIGURE 3: PEDESTRIAN TUNNEL UNDER CSAH 101

One of the project goals was to create a multimodal corridor that accommodates pedestrian and bicyclists as well as vehicle traffic. Trails were constructed on both sides of the north half of the roadway and only on one side of the roadway on the south half to balance property and environmental impacts and reduce earthwork costs through the bluff area. A RRFB pedestrian signal was installed midway through the corridor to facilitate a safe at-grade trail crossing and prefabricated bridges were constructed over CSAH 101 and Bluff Creek to facilitate Minnesota River Bluffs regional trail and local trail crossings. A pedestrian tunnel was also constructed to facilitate a trail crossing under CSAH 101.

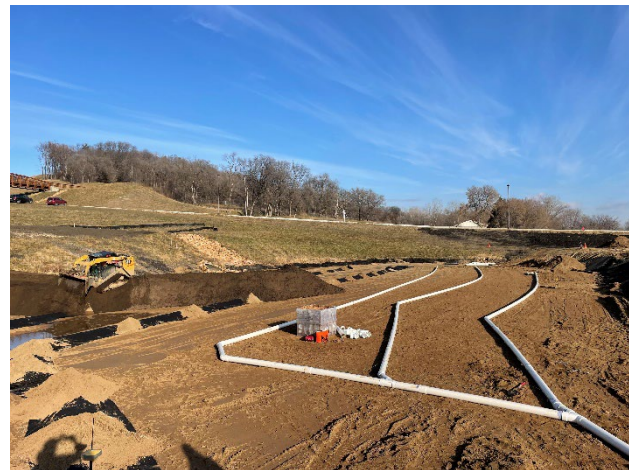
FIGURE 4: DRAIN TILE CONSTRUCTION FOR STORMWATER BMP

Site constraints included steep slopes, highly erodible soils, wetland impacts and floodplain impacts. The optimal locations for stormwater management BMPs were unfortunately in areas consisting of muck soils and high groundwater. The resulting design used two filtration basins—one basin was constructed with a liner underneath to reduce seepage to the roadway embankment fill. The design included a multistage outlet structure that diverted flows for most rainfall events away from the eroding east ravine to the larger stormwater basin on the south end of the project. These features, along with a floodplain no-rise analysis on Bluff Creek, allowed the project to obtain approvals from two watershed districts.

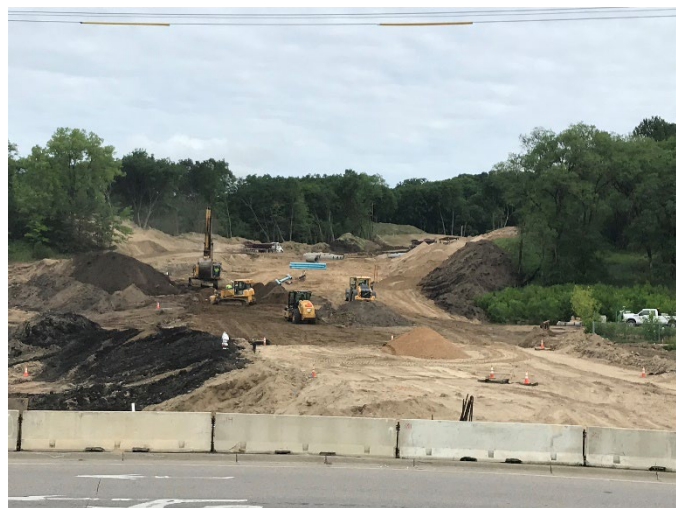
FIGURE 5: EARTHWORK OPERATION TO REMOVE 430,000 CY OF MATERIAL

Due to the nature of the project, the earthwork operation was very complex with more than 430,000 cubic yards of material removed from the site, a 30-foot-deep muck excavation adjacent to an active roundabout, and a 40-foot fill in an existing ravine. The contractor established a process to excavate the muck and backfill with select granular material concurrently to maintain a stable excavation area. They filled the deep ravine in the first construction season and surcharged it by stockpiling select granular material to minimize settlement in the roadway during the second construction season.

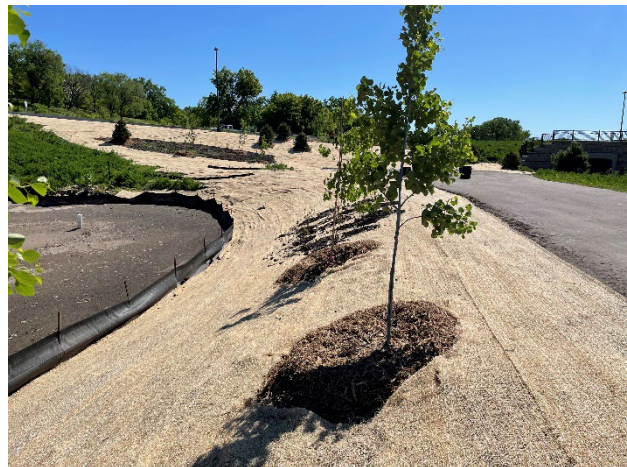
FIGURE 7: TREE PLANTINGS ALONG TRAIL AND ADJACENT TO STORMWATER BMP

Due to the realignment of the roadway and significant grading, numerous trees were removed. The project included a robust reforestation plan consisting of more than 1,300 trees and 550 shrubs to reestablish the graded areas along the project corridor. The contractor mined more than 50,000 cubic yards of select granular material from on site to substantially reduce the amount of trucking. The project included the framework of an innovative in-pavement anti-icing system to be installed in the future which will dramatically reduce the amount of sodium chloride used on the roadway that could ultimately discharge into Bluff Creek and the Minnesota River.

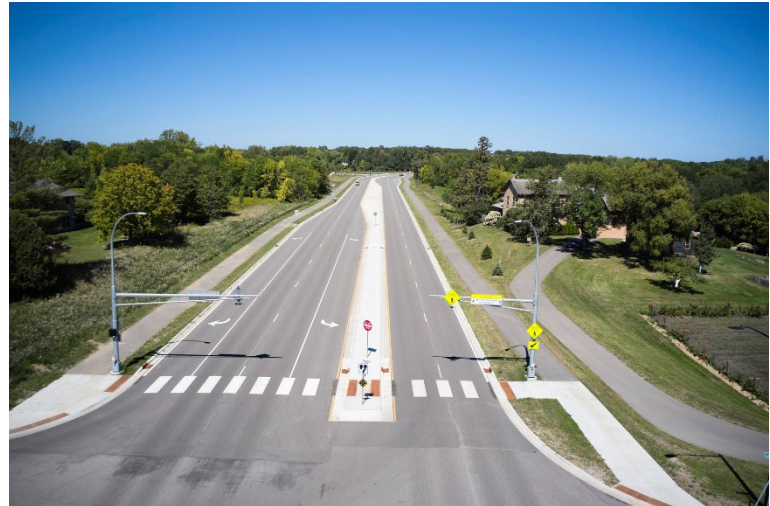
FIGURE 8: CSAH 101 WITH RRFB PEDESTRIAN CROSSING

The existing rural section roadway provided no opportunities for pedestrians and bicyclists to travel the corridor. The project included the construction of trails along both sides of the roadway, a rectangular rapid flashing beacon (RRFB) pedestrian crossing, construction of a prefabricated bridge over CSAH 101 to facilitate the Minnesota River Bluffs regional trail crossing, construction of a second prefabricated bridge over Bluff Creek to facilitate a trail crossing along Flying Cloud Drive, and installation of a pedestrian tunnel under CSAH 101.

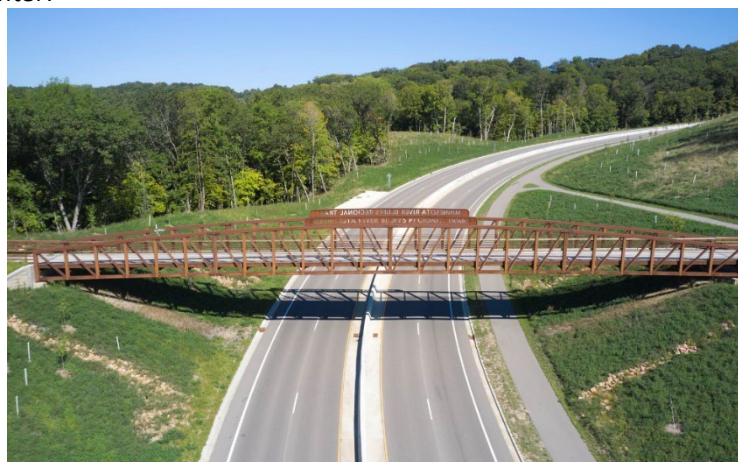
FIGURE 9: PEDESTRIAN BRIDGE OVER CSAH 101
